Ruins Stabilization in the Southwestern United States

RUINS STABILIZATION IN THE SOUTHWESTERN UNITED STATES

**ROLAND VON S. RICHERT and
R. GORDON VIVIAN**

National Park Service
U. S. Department of the Interior
Washington 1974

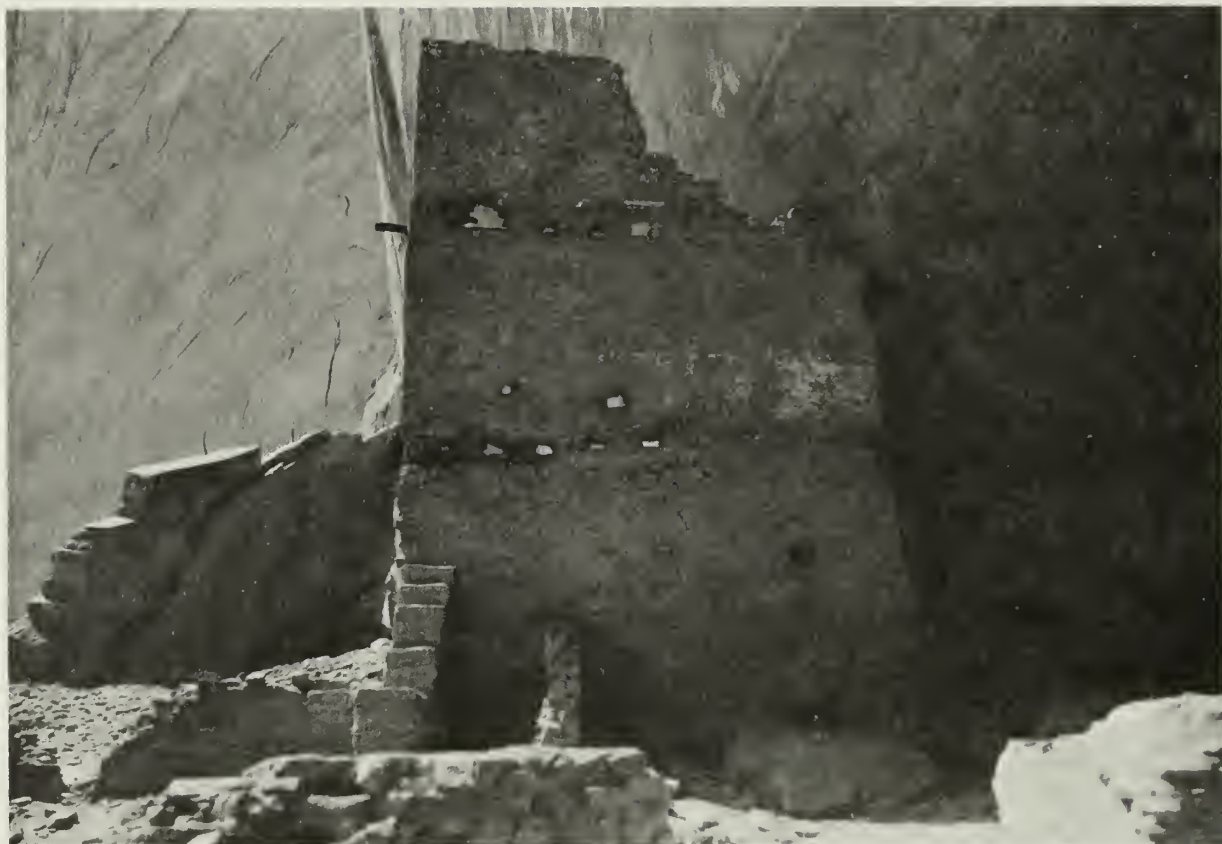
FIGURE 1. Settling caused by lack of foundations and unstable fill. Bond between stone and soil mortar is poor. Holes are caused by decay or theft of wood members. (Antelope House Ruin, Canyon de Chelly National Monument, Ariz.)

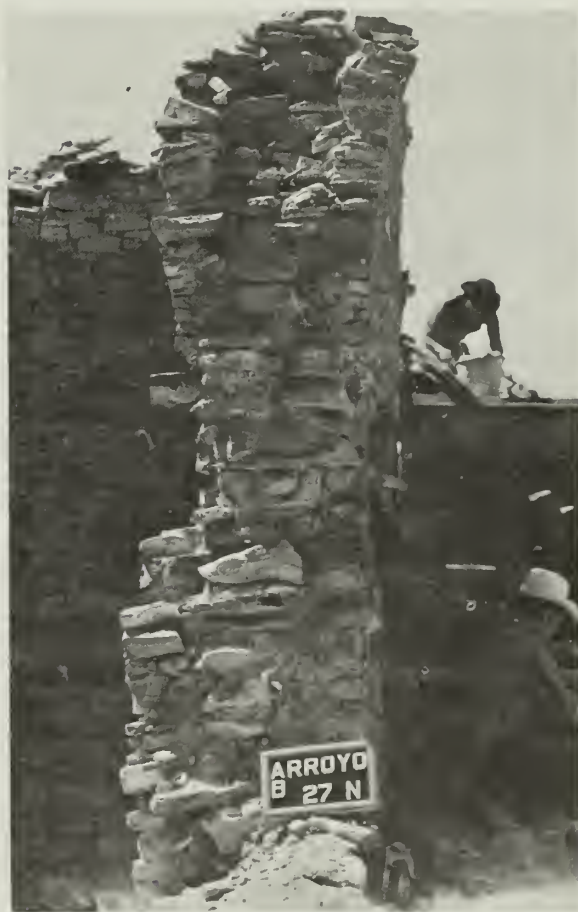
FIGURE 2. Aboriginal construction often left narrow strips at ceiling line. This wall is much wider at the top than in the center. (Room 27, north wall, Pueblo del Arroyo Ruin, Chaco Canyon National Monument, N. M.)

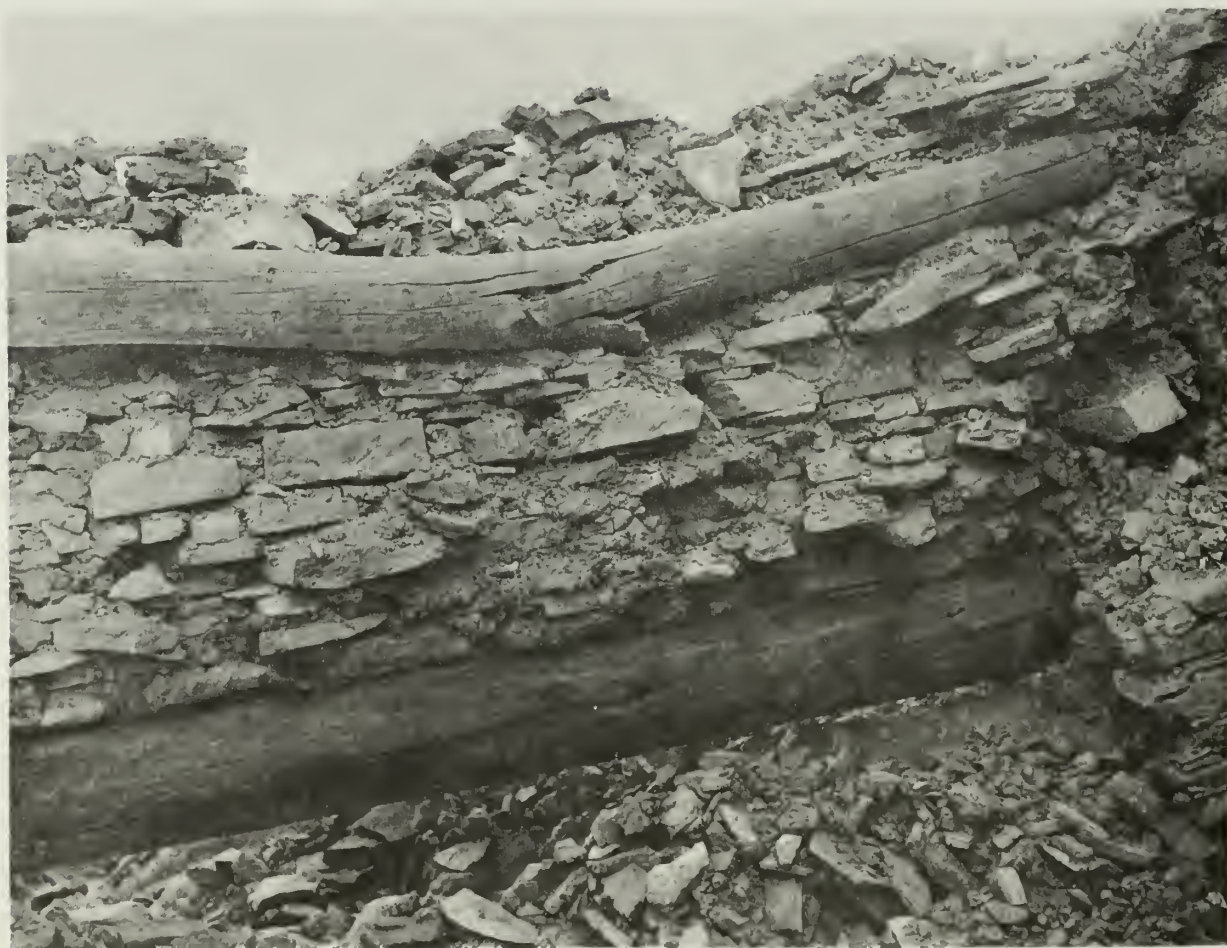
FIGURE 3. The inclusion of heavy timbers within cored-type walls was a usual practice of prehistoric builders. Collapse of walls from flood damage at Chetro Kettle exposed 300 logs similar to those above. (Chetro Kettle Ruin, Chaco Canyon National Monument, N. M.)

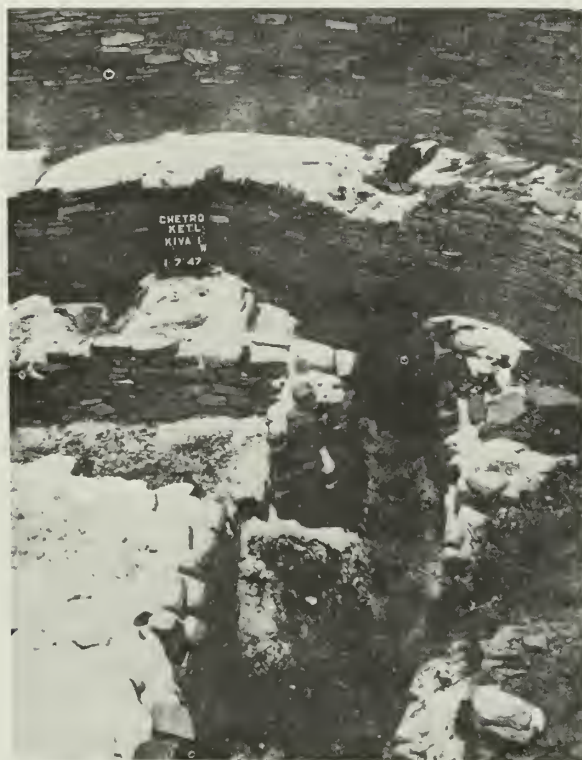
FIGURE 4. Excavation neither proceeds nor ends on a single plane and often leaves walls unsupported. (Kiva I, west perimeter, Chetro Kettle Ruin, Chaco Canyon National Monument, N. M.)

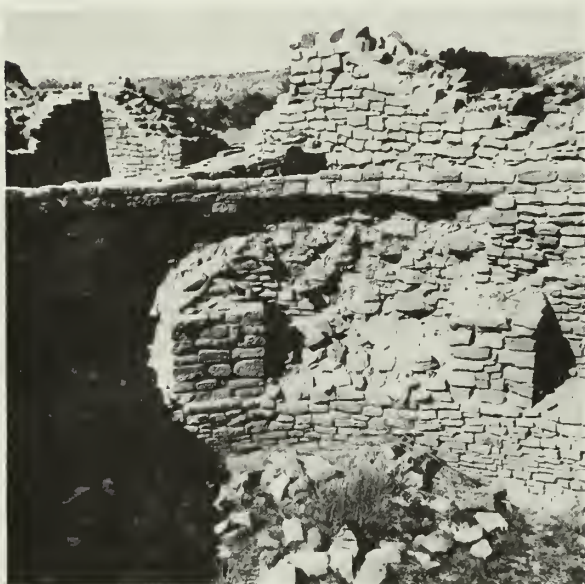
FIGURE 15. Damage caused by outward movement of moisture from fill behind kiva wall. The most severe disintegration is at the limit of capillary rise, just below the concrete capping. (Clan Kiva, West Ruin, Aztec Ruins National Monument, N. M.)

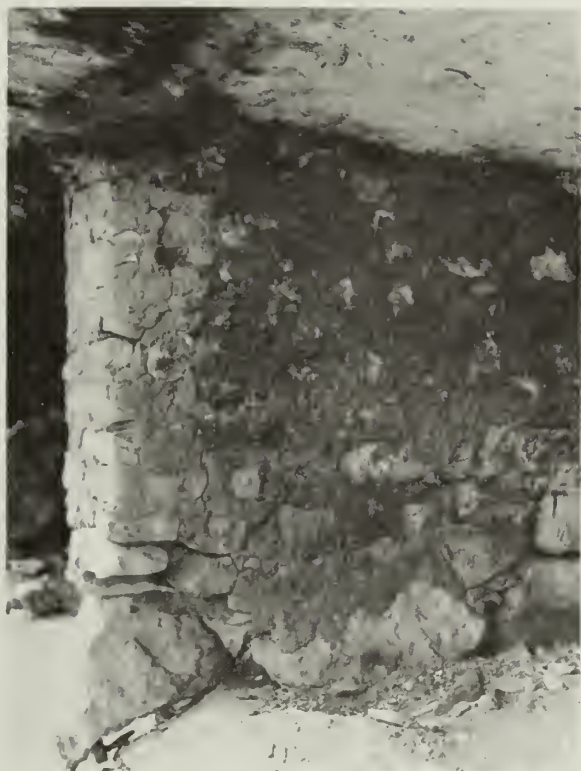
FIGURE 16. Damage as the result of rising moisture from melting snow. Note that decay is confined to the limit of capillary rise in the mortar column. (Cliff dwelling in Walnut Canyon National Monument, Ariz.)

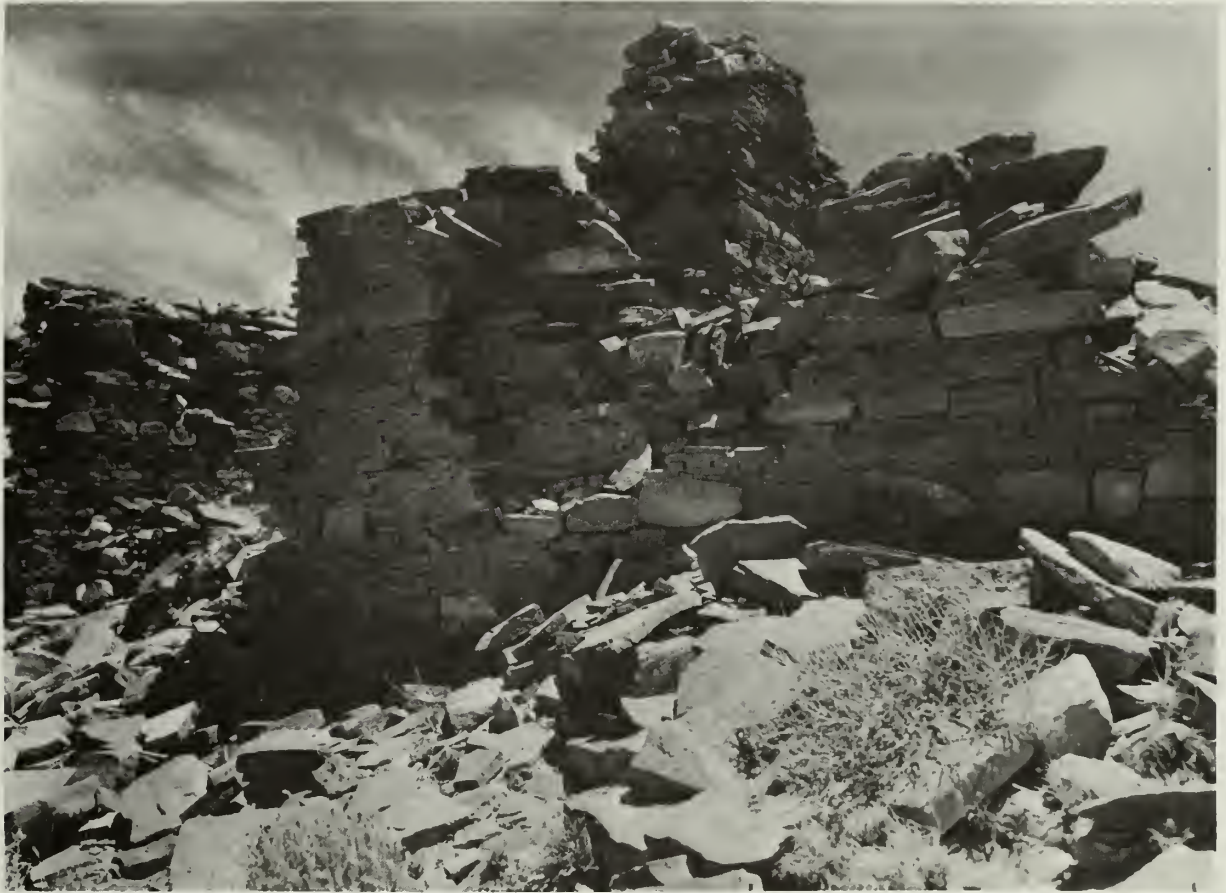
FIGURE 23. An example of soft, pecked and dimpled stone in random areas over wall surface. Replacement of the stone requires extreme care if the character of the wall is not to be changed. (Peñasco Blanco Ruin, Chaco Canyon National Monument, N. M.)

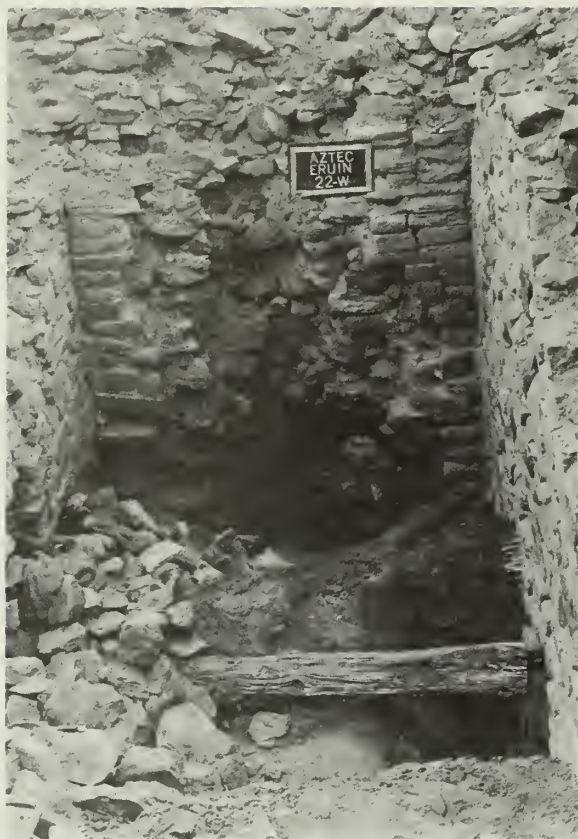
FIGURE 24. Wall break in a partially excavated site. A patch must be designed to prevent further flow of water and fill at the top, and some excavation will be required to base patch on sound masonry. (East Ruin, Aztec Ruins National Monument, N. M.)

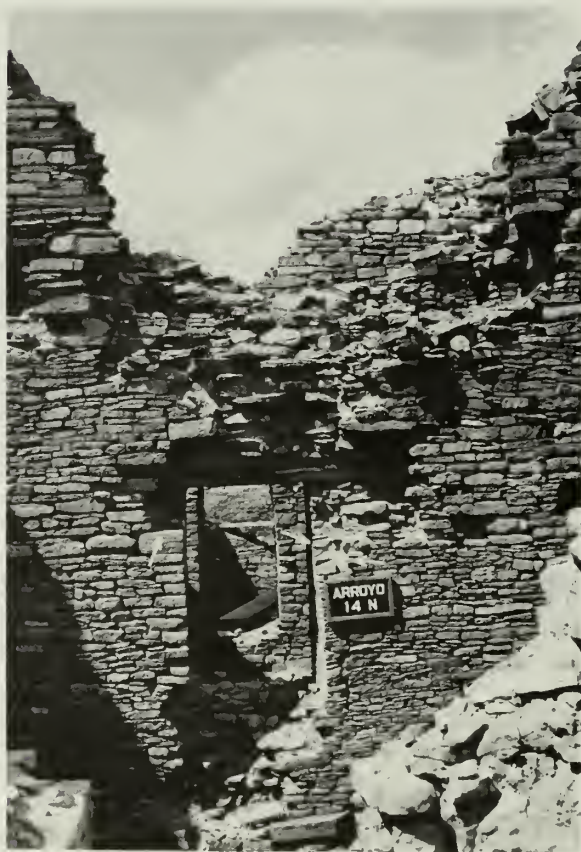
FIGURE 25. Repair at the position of the arrows will be based on a very small area in comparison with the total size of break. Every effort should be made to tie such patches securely to the existing wall. (Pueblo del Arroyo Ruin, Room 14, north wall, Chaco Canyon National Monument, N. M.)

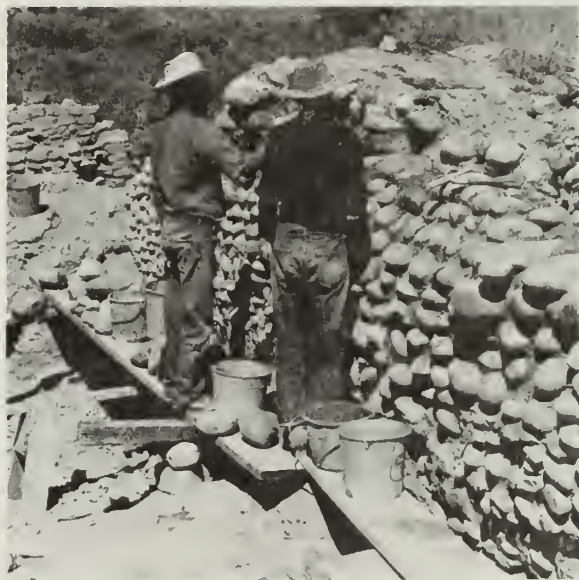
FIGURE 26. Deep grouting with soil-cement on the badly weathered face of this cobblestone wall will not change its appearance, but will halt the rapid rate of erosion. (East Ruin, Aztec Ruins National Monument, N. M.)

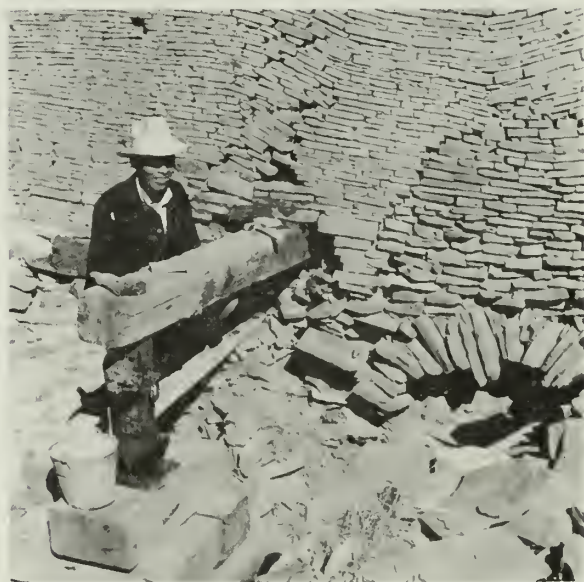
FIGURE 28. The temporary support of a heavy wall with timber. The arch at lower right was constructed in the 1920's as a repair measure. The first step in stabilization involved the placing of a beam through a hole adjacent to the arch. Not of aboriginal origin, the arch was subsequently removed. (Room 1, Chetro Kettle Ruin, Chaco Canyon National Monument, N. M.)

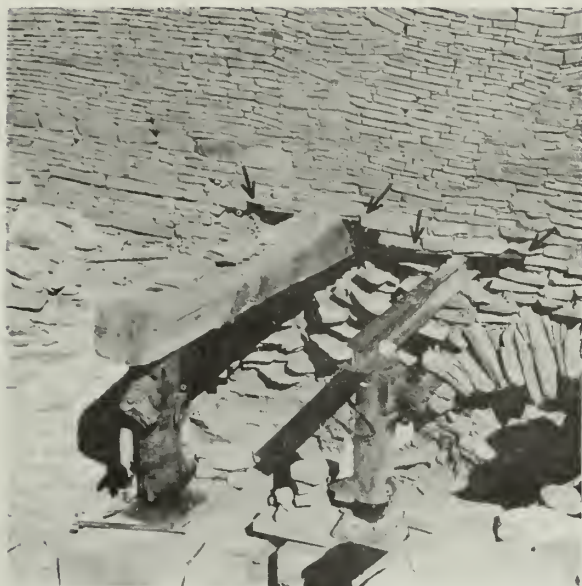
FIGURE 29. A second beam resting on jacks is placed through the wall depicted in figure 28. Arrows indicate extent of steel plates above the beam. The area of settling was reduced with upward pressure.

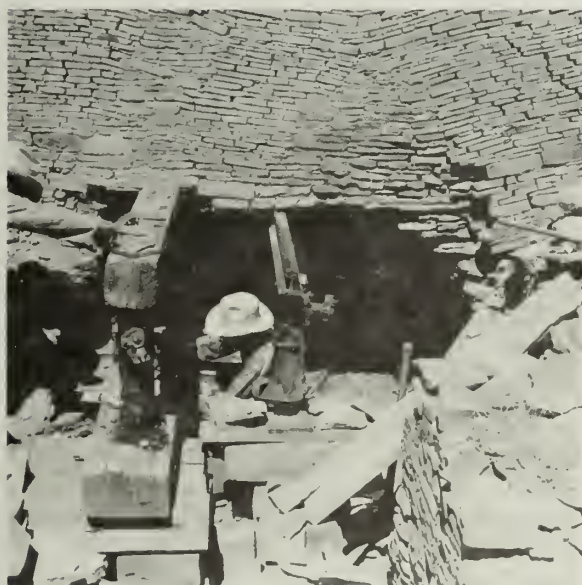
FIGURE 30. Jacks and beams provide support of wall depicted in figures 28 and 29 while arch section is removed. The break is filled with repair masonry.

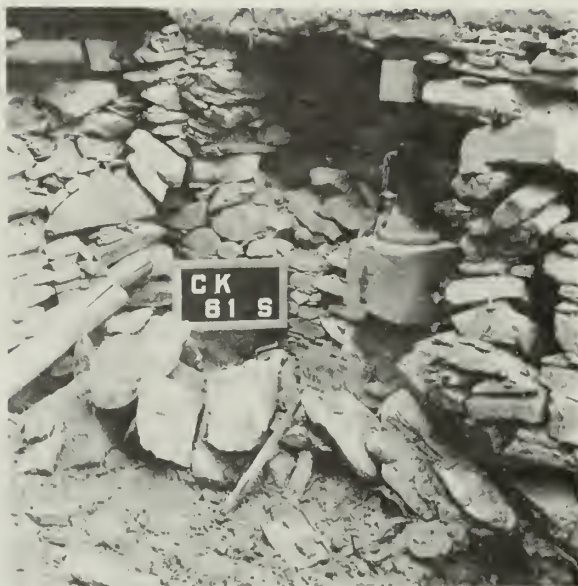
FIGURE 31. Placement of jack in line with shattered facing near the bottom of a 14-foot wall. The jack provided support while the broken area at the right was being replaced. (Chetro Kettle Ruin, Chaco Canyon National Monument, N. M.)

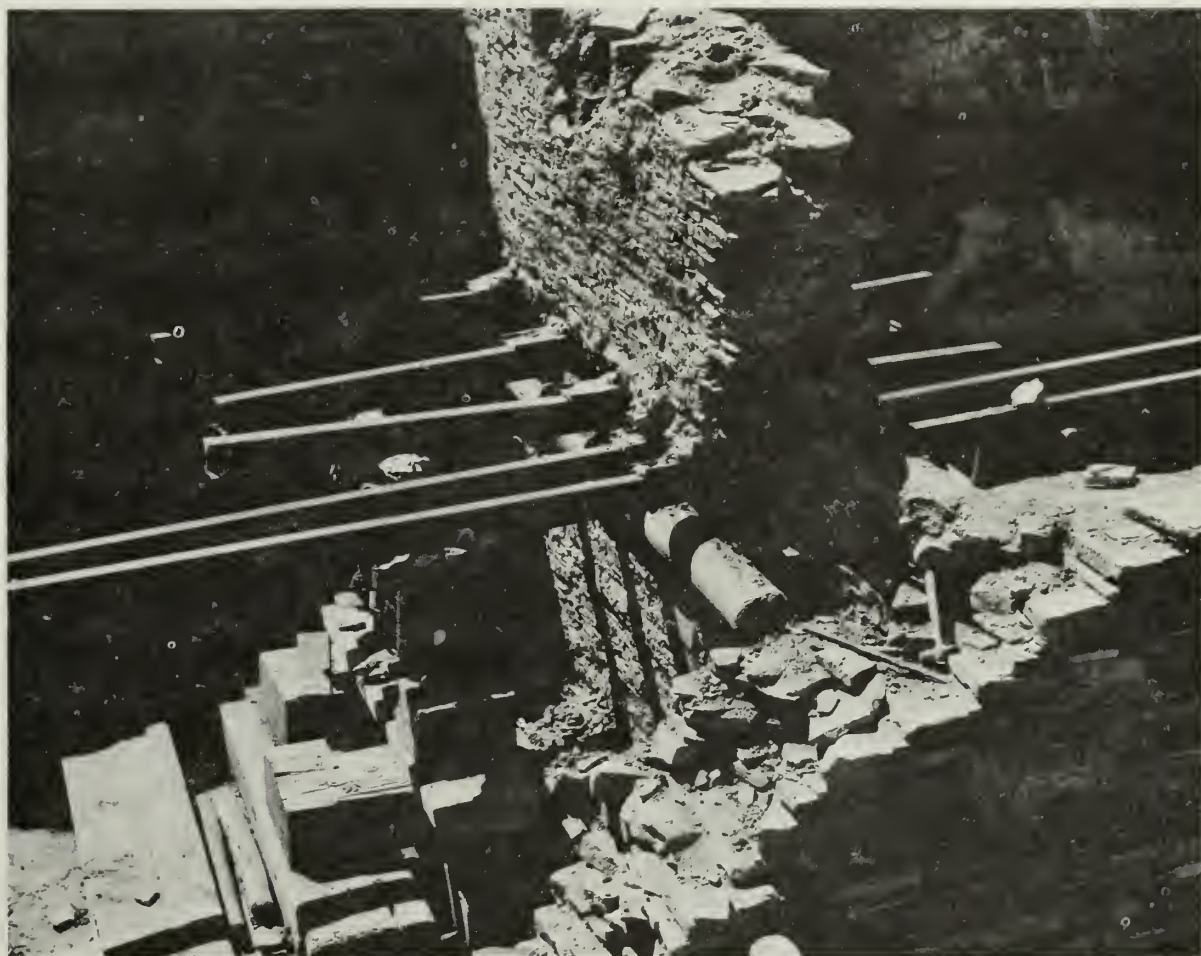
FIGURE 32. A temporary support. Six steel beams buttress the upper half of the wall while a decayed horizontal timber is replaced. The timber is partly removed here. With care, steel beams can be run through pole sockets or other natural openings without damage to the wall. (Chetro Kettle Ruin, Chaco Canyon National Monument, N. M.)

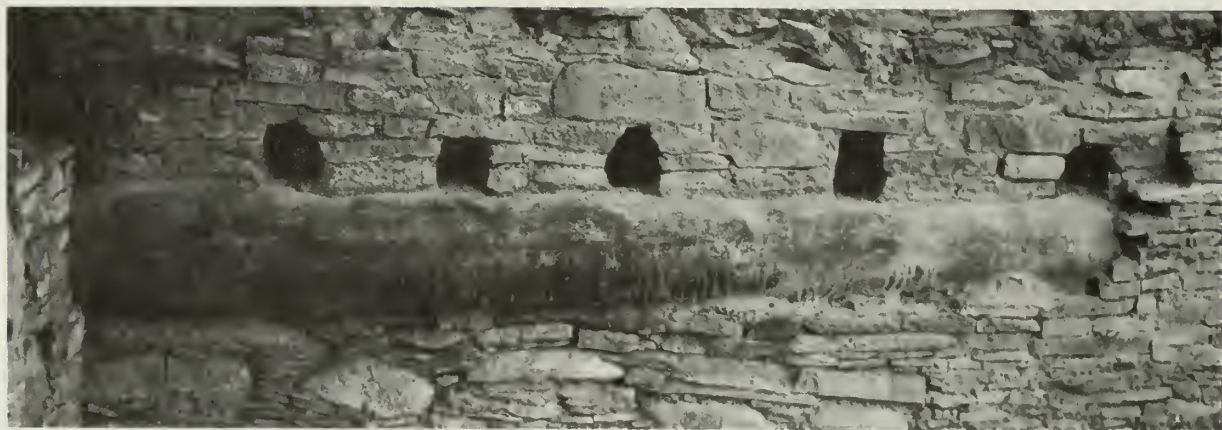
FIGURE 38. A horizontal cast log replaces the original timber which had rotted on the interior and in the embedded portions. (Chetro Kettle Ruin, Chaco Canyon National Monument, N.M.)

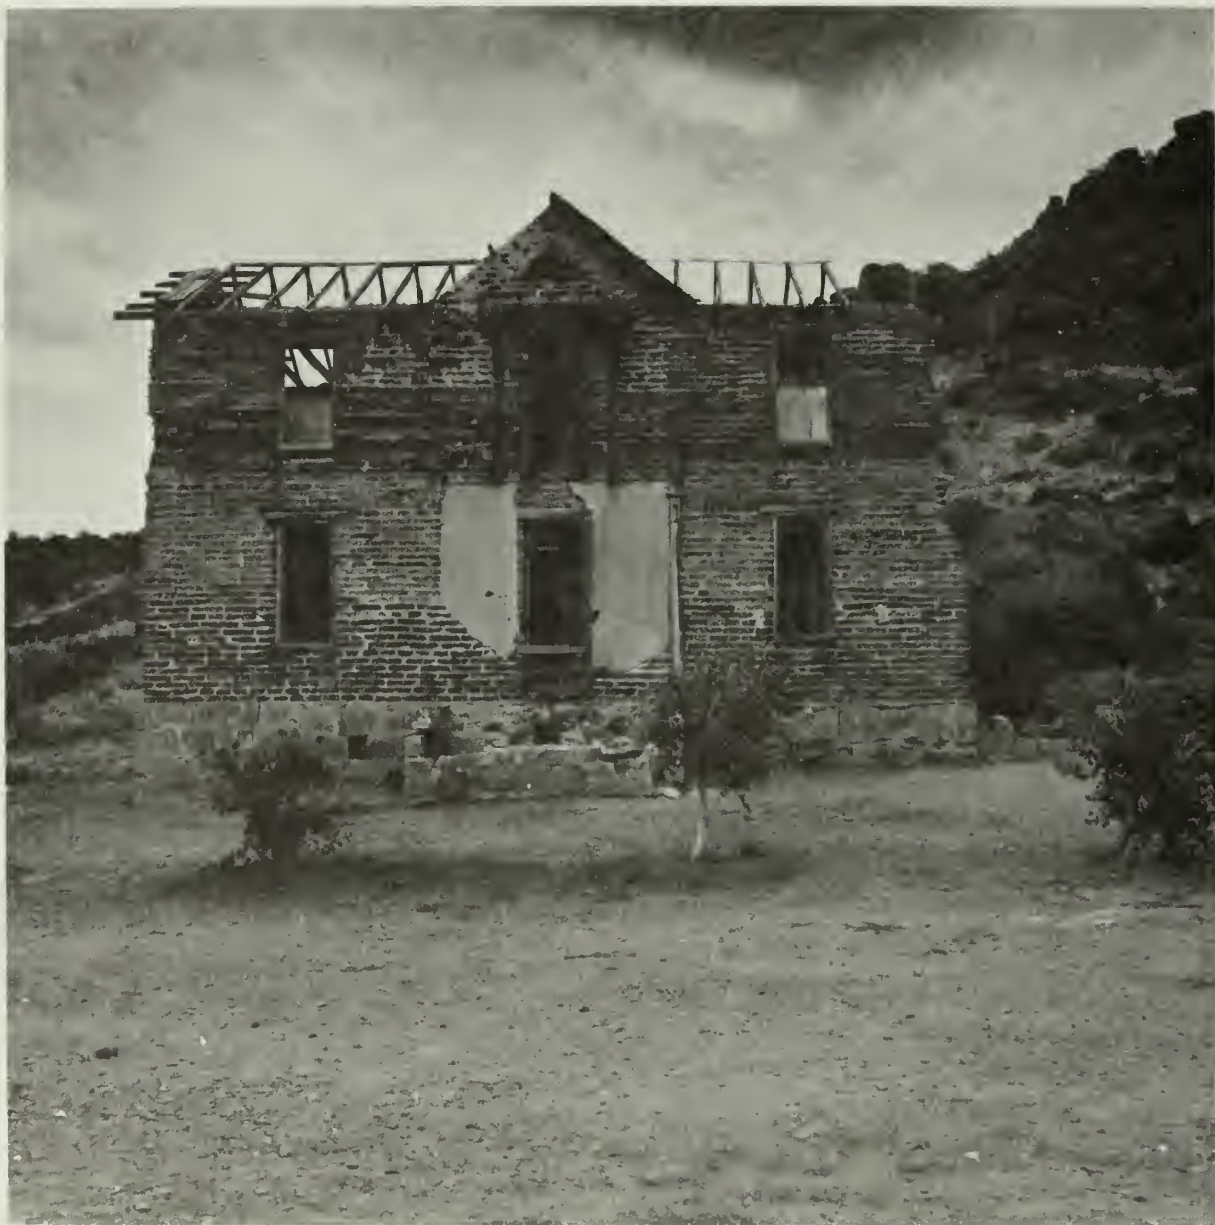
FIGURE 55. One of four 2-story adobe structures, designated HB-14, at Fort Davis National Historic Site. The building was probably used as a residence for important non-commissioned officers. Front view in 1964 before repairs were undertaken by the National Park Service.

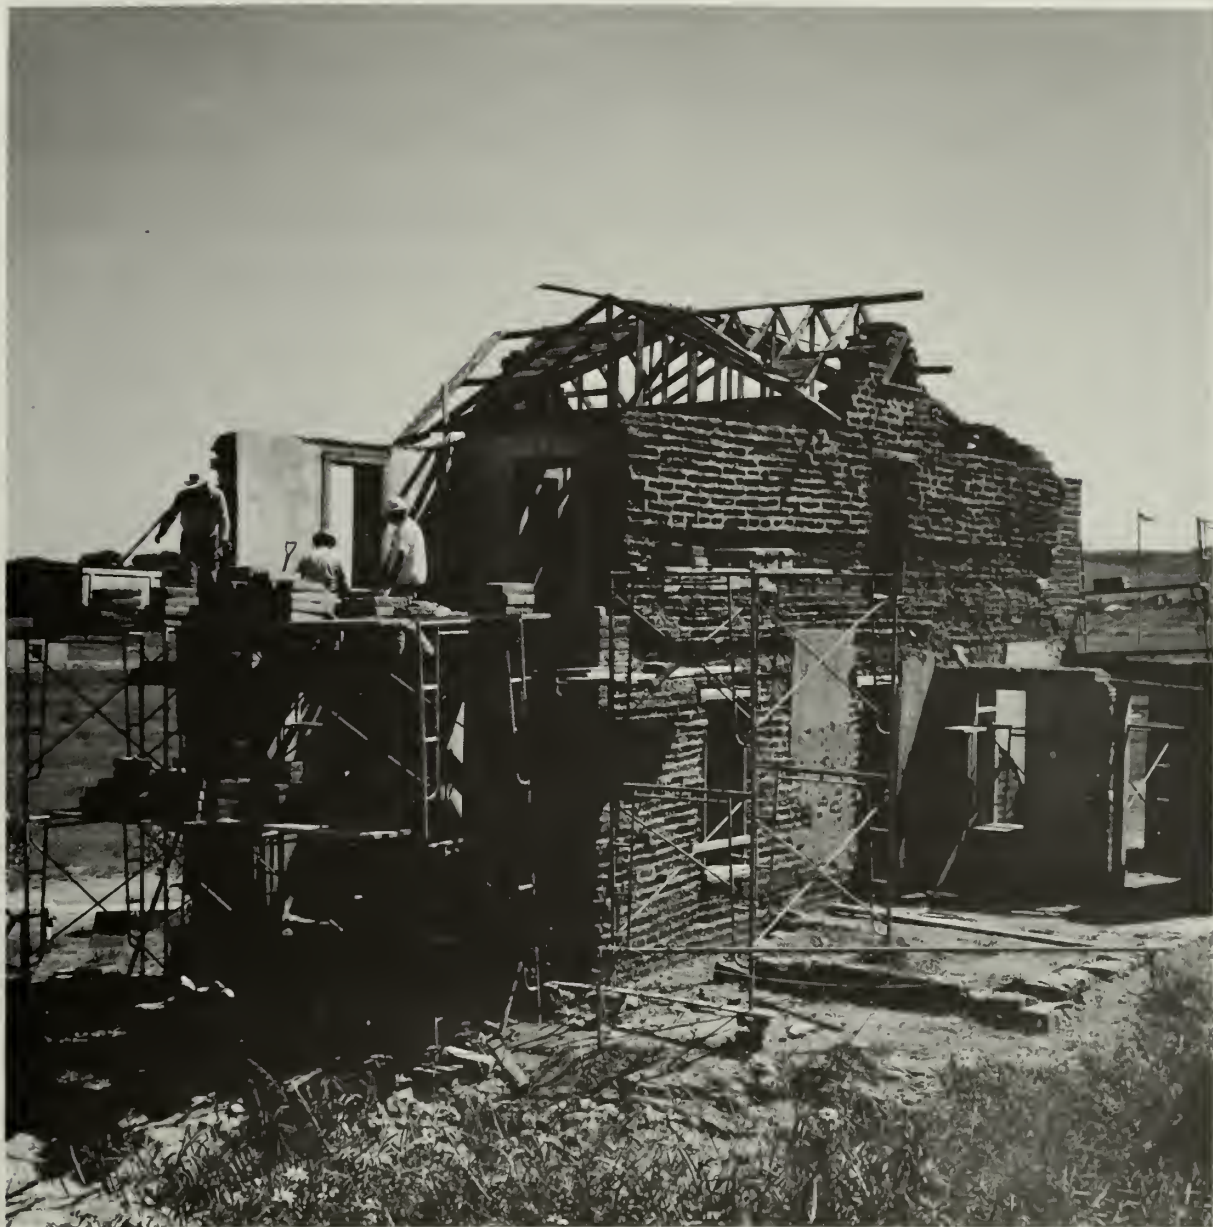
FIGURE 56. Stabilization and modified restoration in process at HB-14, shown in figure 55. Soil-cement adobes were used for repairing walls. A concealed integral bond beam was installed around the building between the first and second story levels. Concrete bearing beams were installed at roof line to support restored roof.

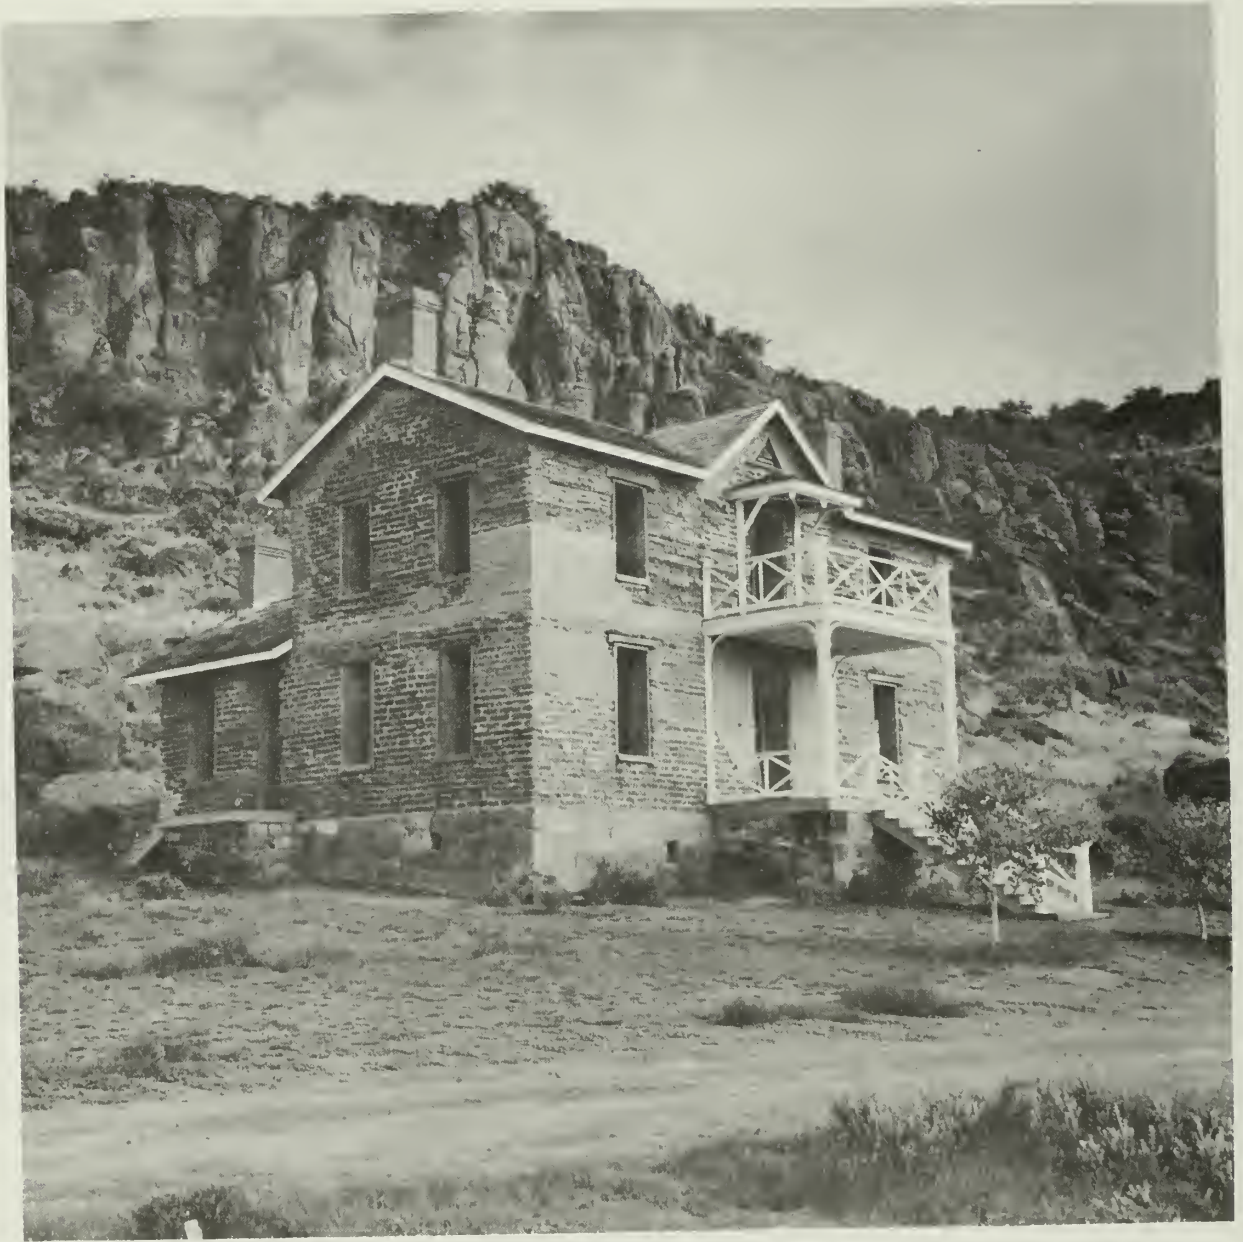
FIGURE 57. The completed stabilization and modified restoration of building HB-14, Fort Davis National Historic Site. Compare with figures 55 and 56.

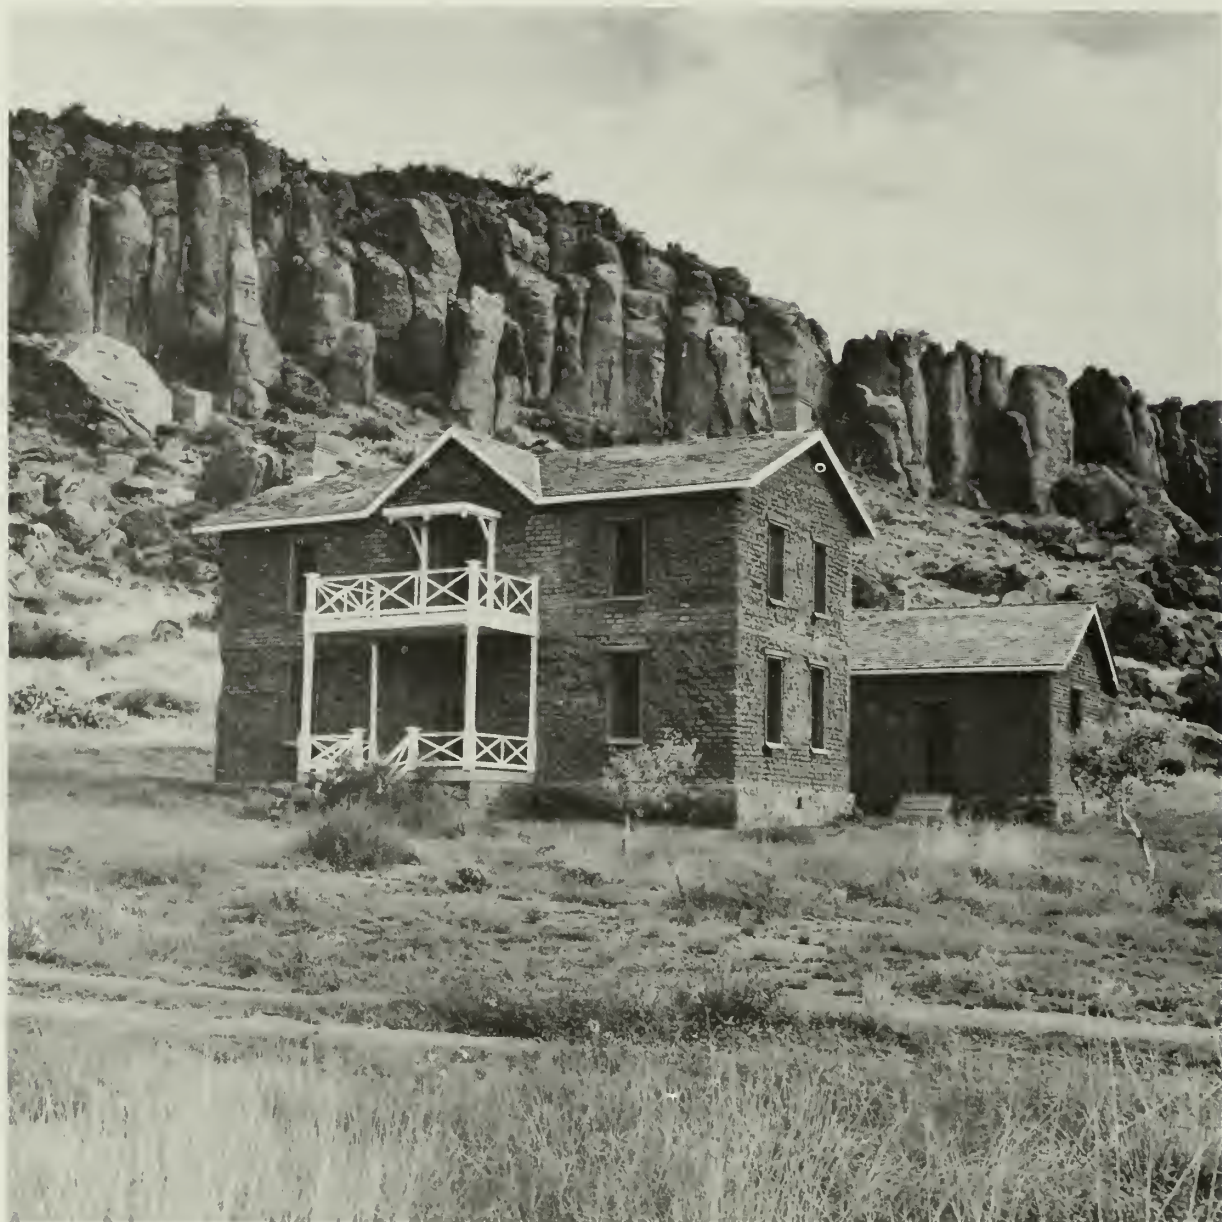
FIGURE 59. Building HB-15 and its outbuilding, a kitchen, following modified restoration by the National Park Service. Soil-cement adobes simulating original adobes were used as modular units of repair. Compare with figure 58.

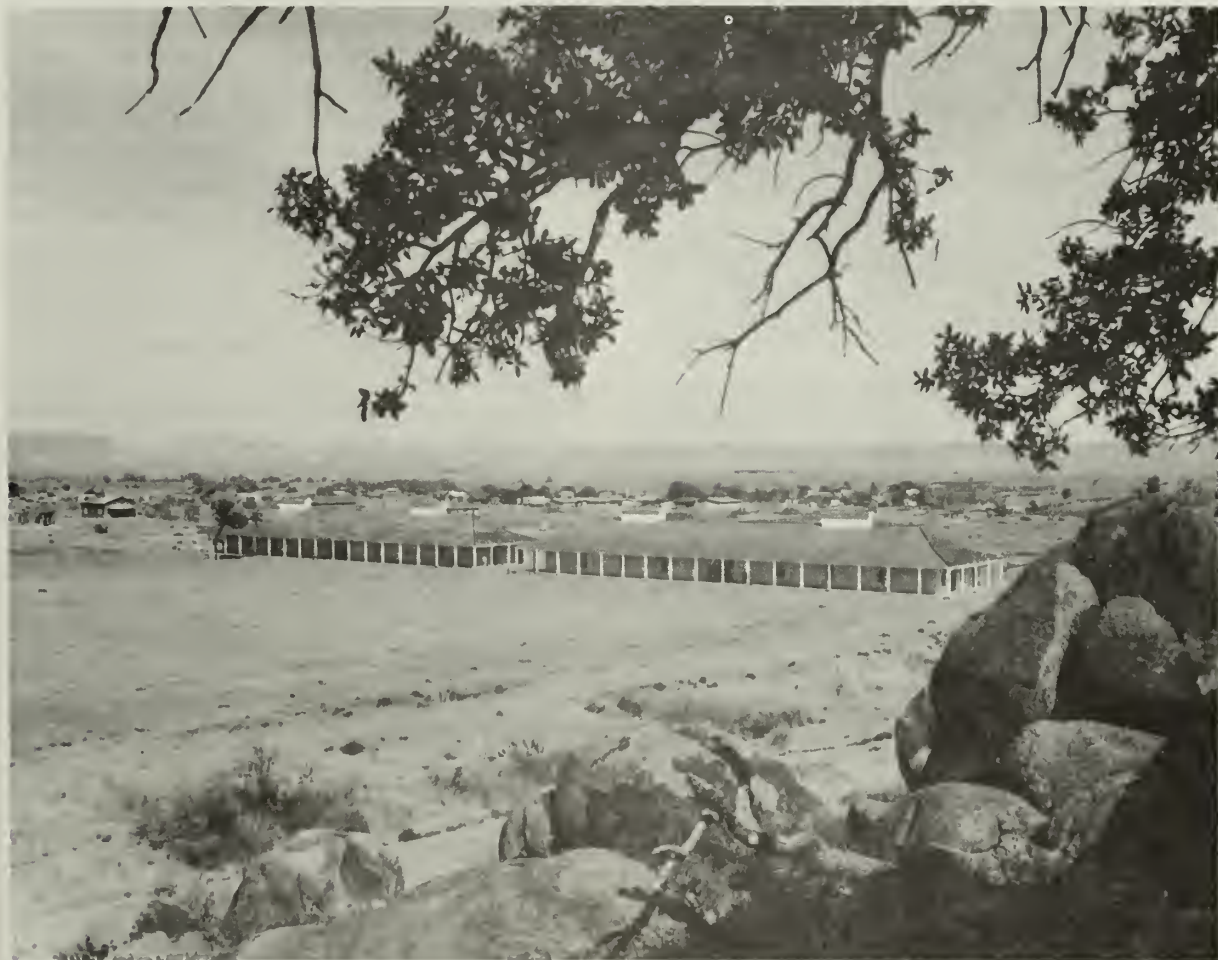
FIGURE 61. A view of the Fort Davis barracks after restoration. The ruinous shell seen in figure 60 was veneered with hand molded soil cement bricks, 4" x 4" x 12". They were made with one part portland cement (untinted), three parts unwashed sand, and three parts native soil. The bricks laid in masonry mortar with rough joints, set with spalls, were wire-brushed. Original walls were pared down where required to accommodate the veneer brick and to retain original wall dimensions and thickness. Bond beams were installed at roof line to support the restored, hipped, shingled roof. The soil cement brick walls were painted with white cement paint, although originally they were whitewashed. The building is used functionally today as the Visitor Center. Cost of the restoration: \$129,000 or \$12.90 per square foot.

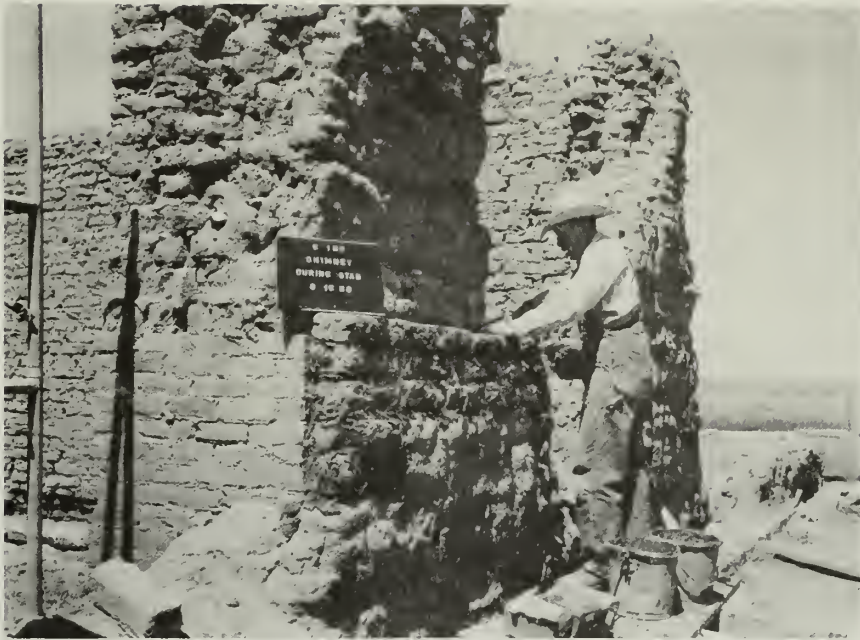
FIGURE 97. Building 6-160, Room 163, flue and chimney in east wall, during stabilization. Soil adobes are being laid to replace those that had fallen away. Fort Union National Monument.

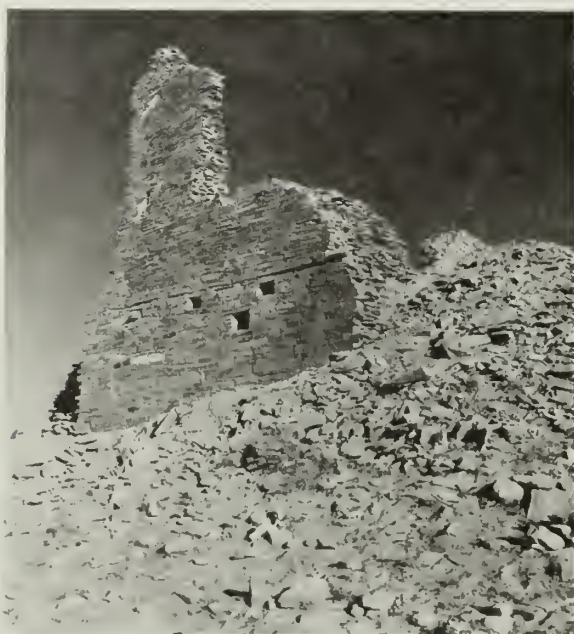
FIGURE 102. Hole at base, square openings (the two upper held beams, the lower was a ventilator) and insets repaired and wall stubs capped. Beam stub at left and two beam holes in line above (arrows) either represent reinforcing ties for kiva corner or supports for some sort of prehistoric scaffolding used in construction or a balcony.

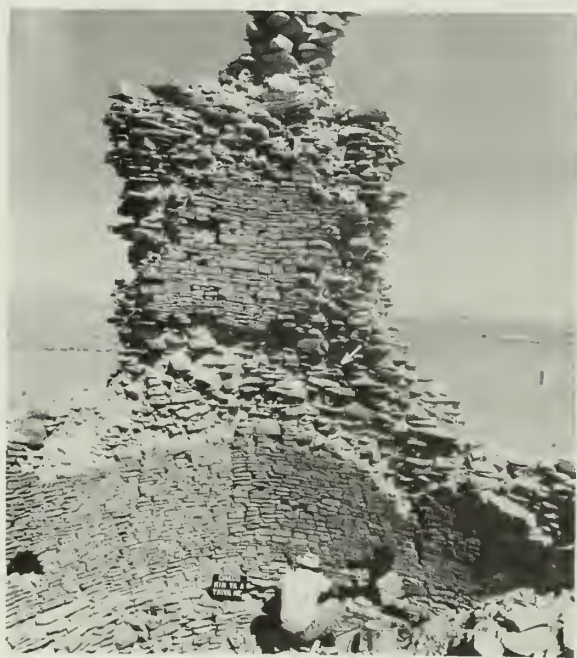
FIGURE 103. General view of northeast interior of Tower Kiva at start of project. The circular wall is stepped back or inset at two points: (1) at narrow ledge or bench where workman is beginning repairs, and (2) where facing is gone, exposing core (arrow).

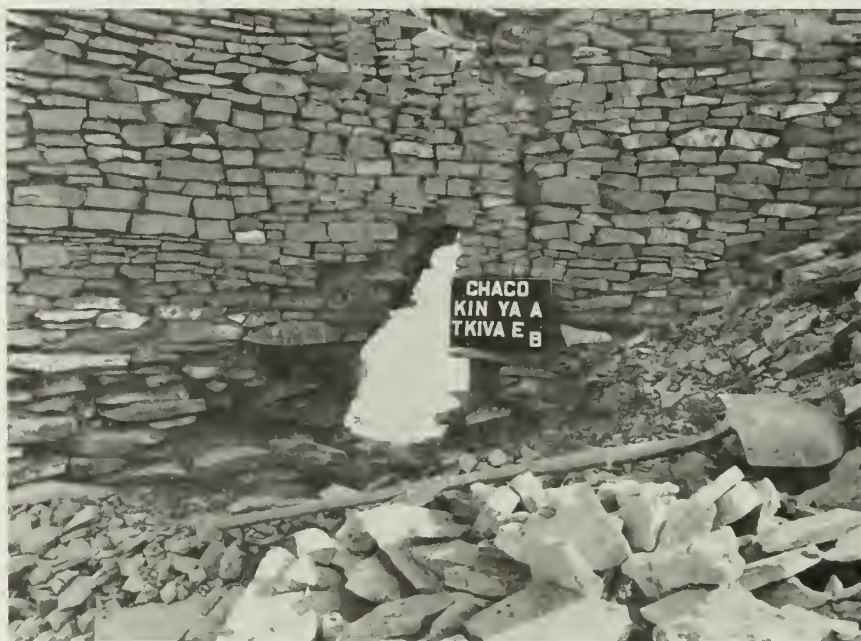
FIGURE 105. Detail of hole in Tower Kiva caused by breakdown of savino sockets. The beams for the sockets extended part way into this wall from the opposite side, and originally supported the ceiling of the adjacent room.

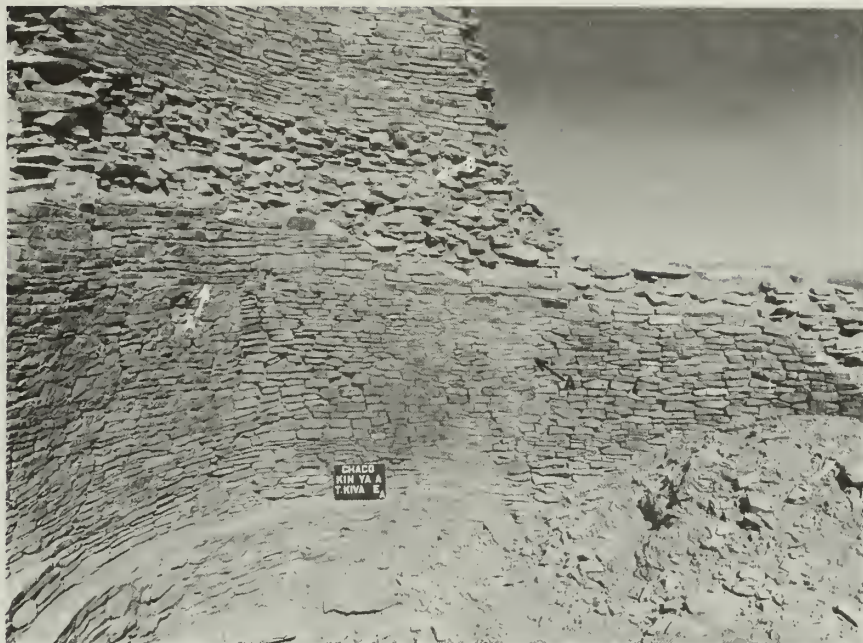
FIGURE 106. Lower portion of Tower Kiva, north and east segments, after stabilization. Offset ledges repaired, holes filled with repair masonry, facing reset (arrows A), top capped and inset core (arrow B) grouted.

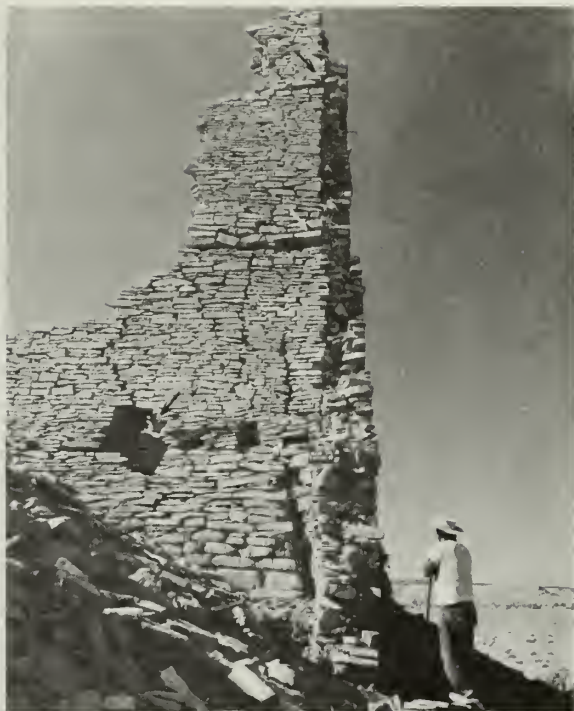
FIGURE 112. Tower Kiva, east wall exterior at juncture with north wall stub (at sign). Note the vertical cracks, eroded savino sockets (arrows) and loose, fragile spire. Portions of 4 stories are visible.
